10. The Unique Nature of the Davis-Besse Nozzle 3 Crack and the RPV Head Wastage Cavity

10.1 Wastage Cavities at Nozzles 3 and 2

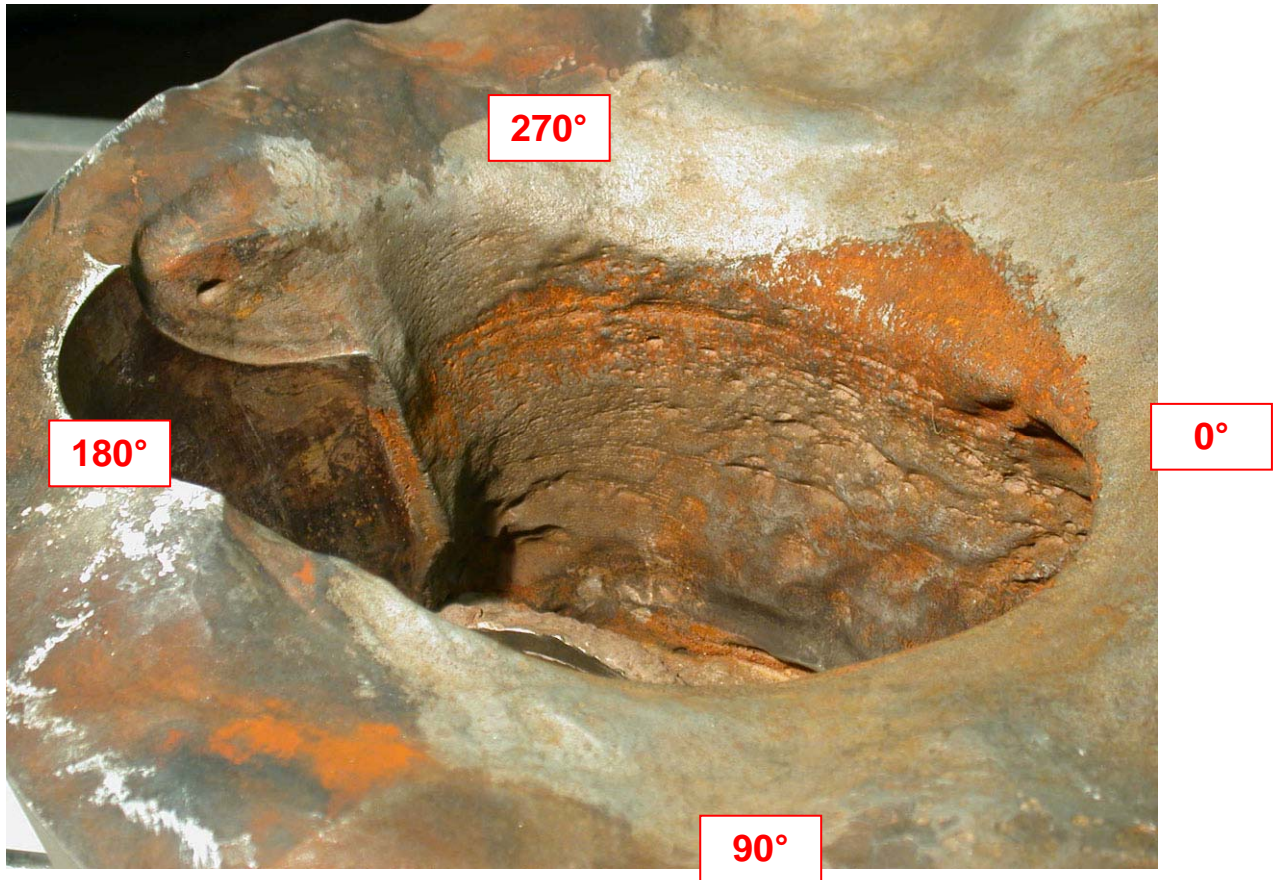
- The corrosion process is clearly more dominant in the upper region of the cavity. There is clear evidence of mechanical removal and/or flow-assisted corrosion in the lower region, where the wastage cavity is clearly undercut. This lower undercut region is indicative of a more rapid metal removal process than at the mid-elevation point of the cavity.

Figure 10.2 View of cavity looking toward 270°

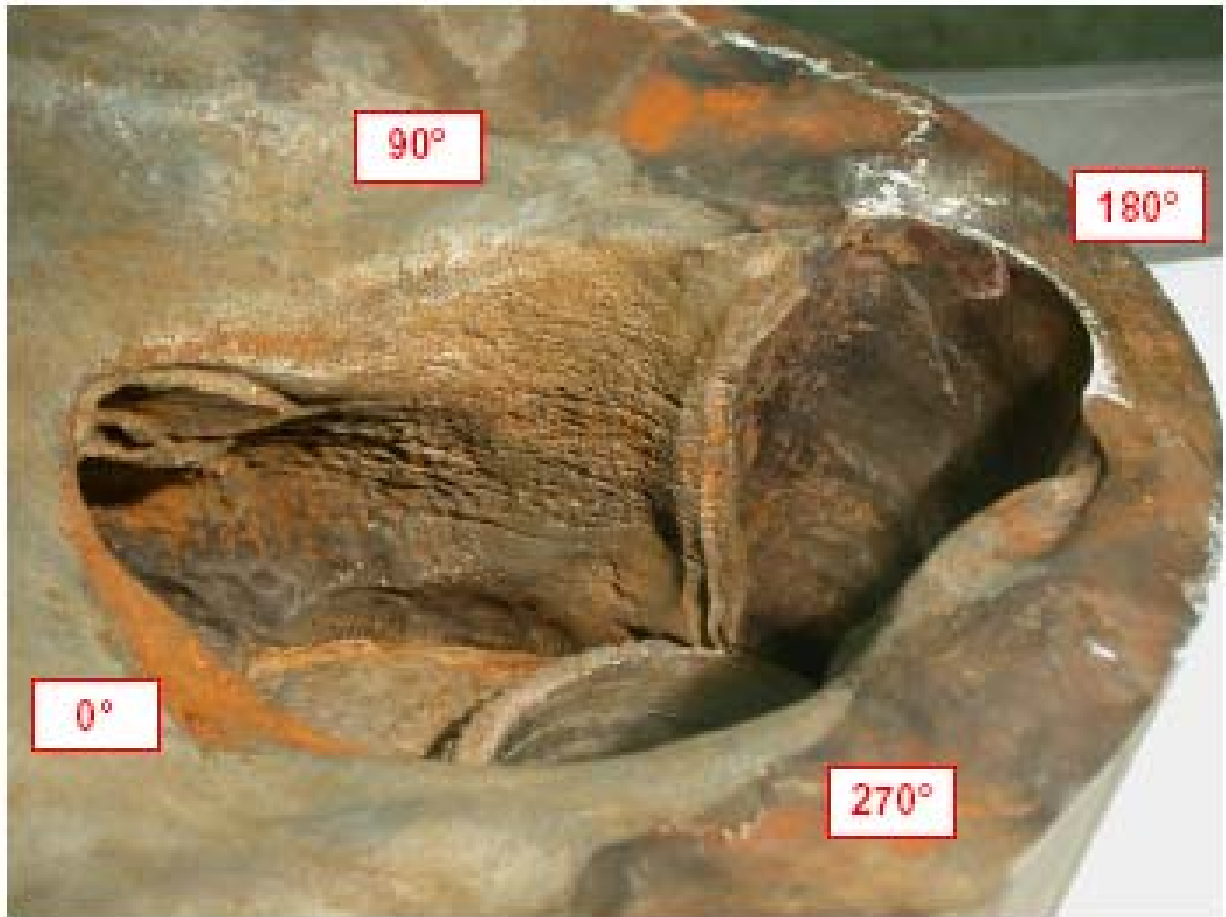
Figure 10.3 View of cavity looking toward 90°

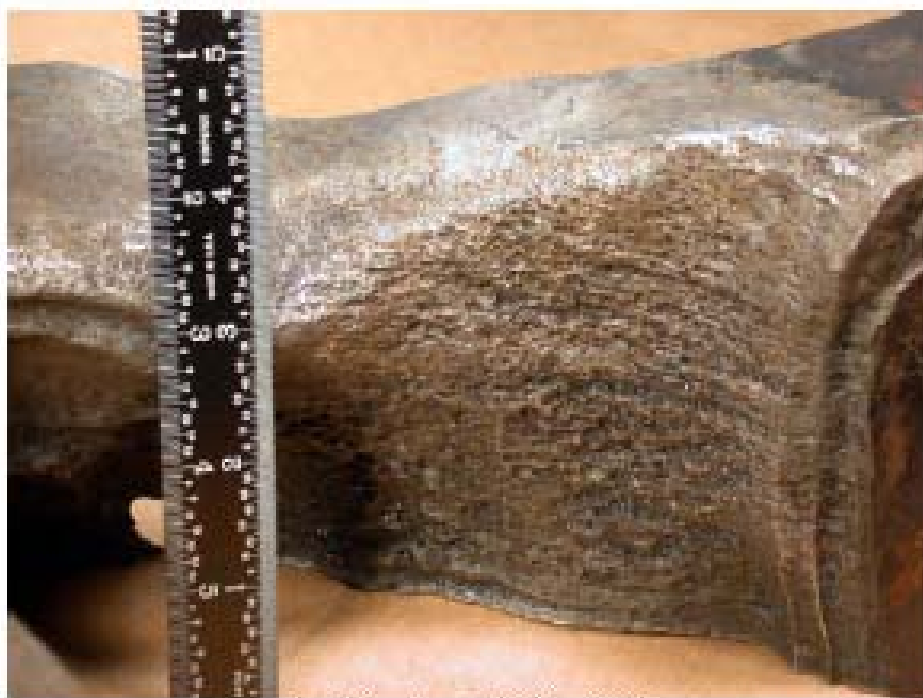
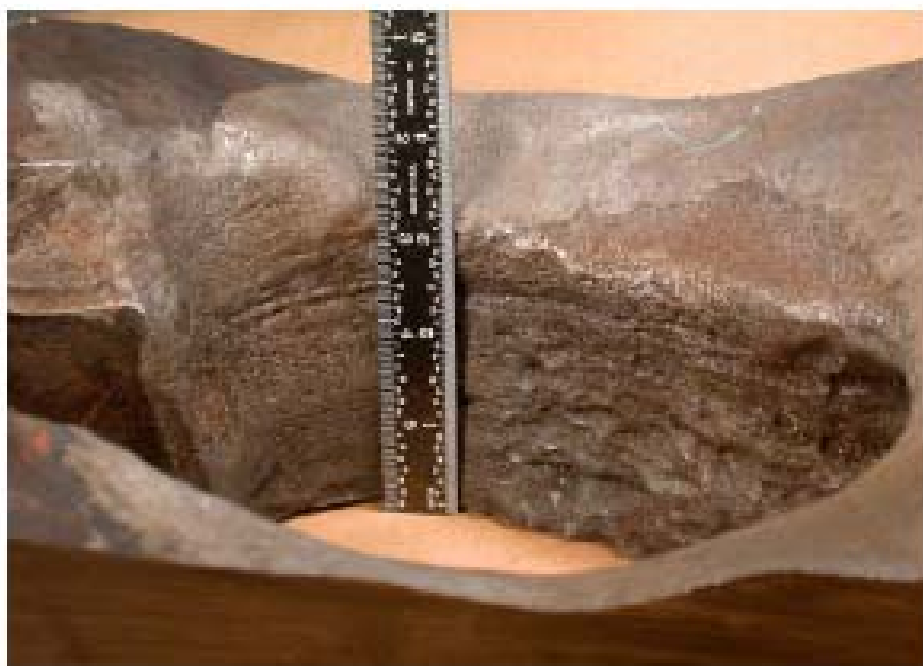
- General corrosion of the upper RPV head surface around the cavity is evident to a depth of 1 to 1.5 inches. This can be seen in the view of the top section of the cavity (Figure 10.4) and more clearly shown in the dental mold impressions (Figure 10.5).

Looking toward 90° ~0.7X

Looking toward 270° ~0.5X

Figure 10.4 Low magnification photographs of cavity sidewalls

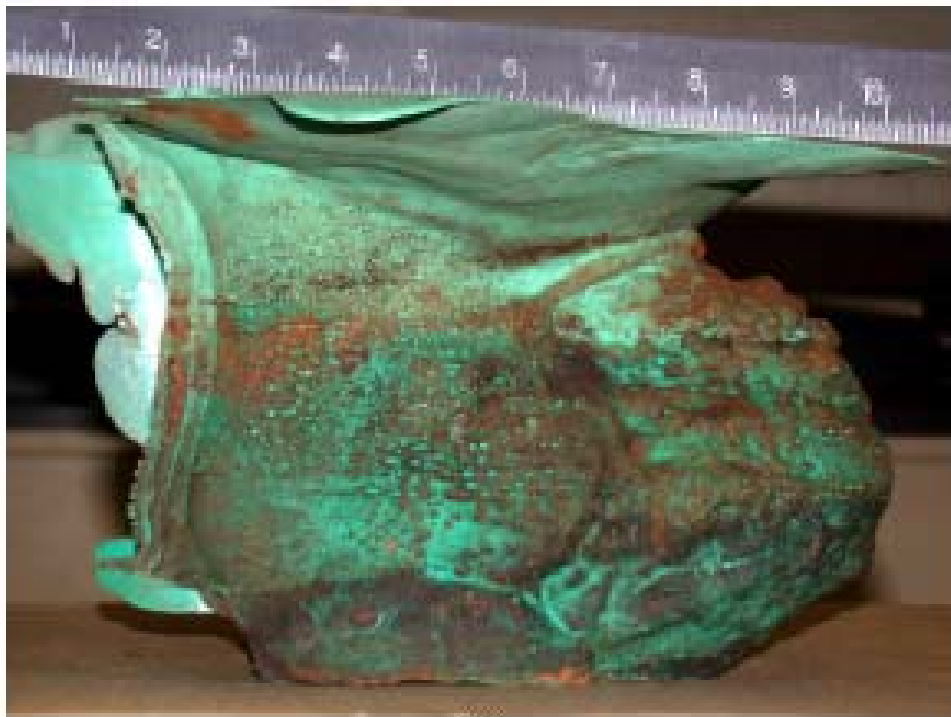
0°

90°

Figure 10.5(a) Photographs of cavity dental mold

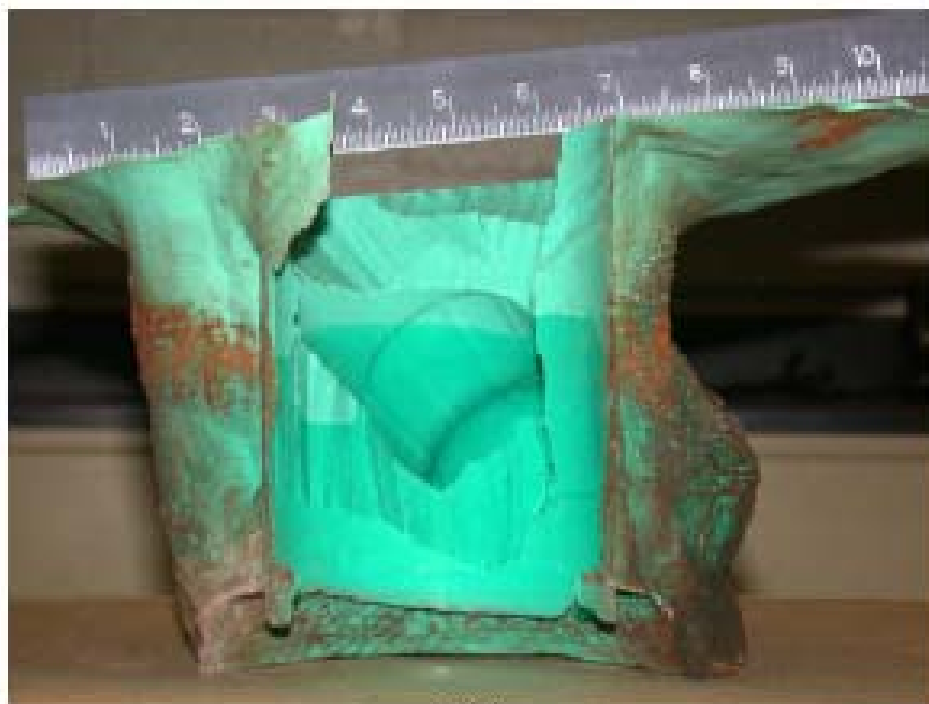
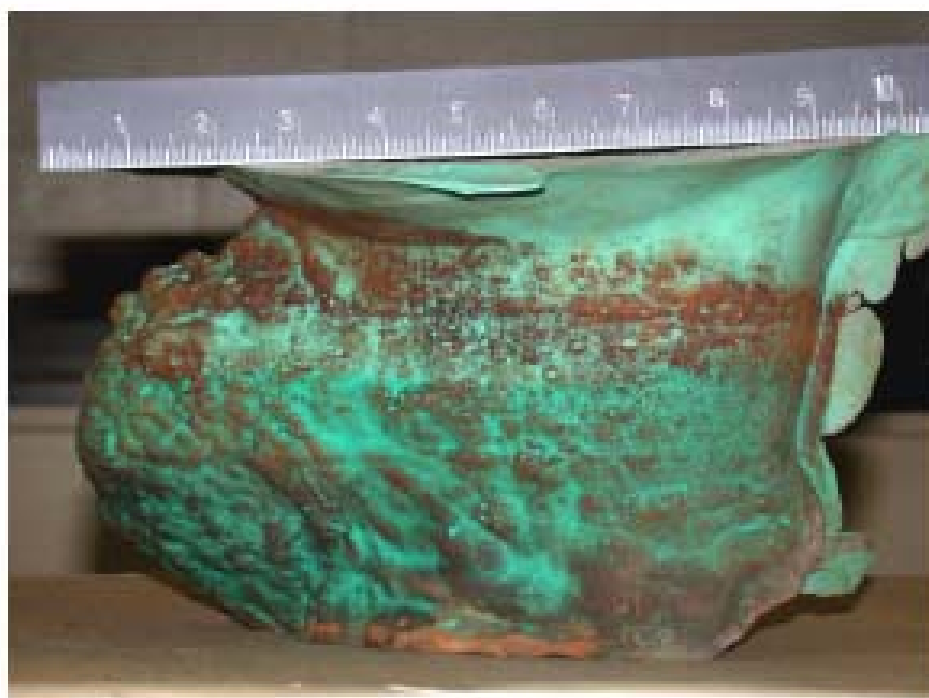
180°

270°

Figure 10.5(b) Photographs of cavity dental mold

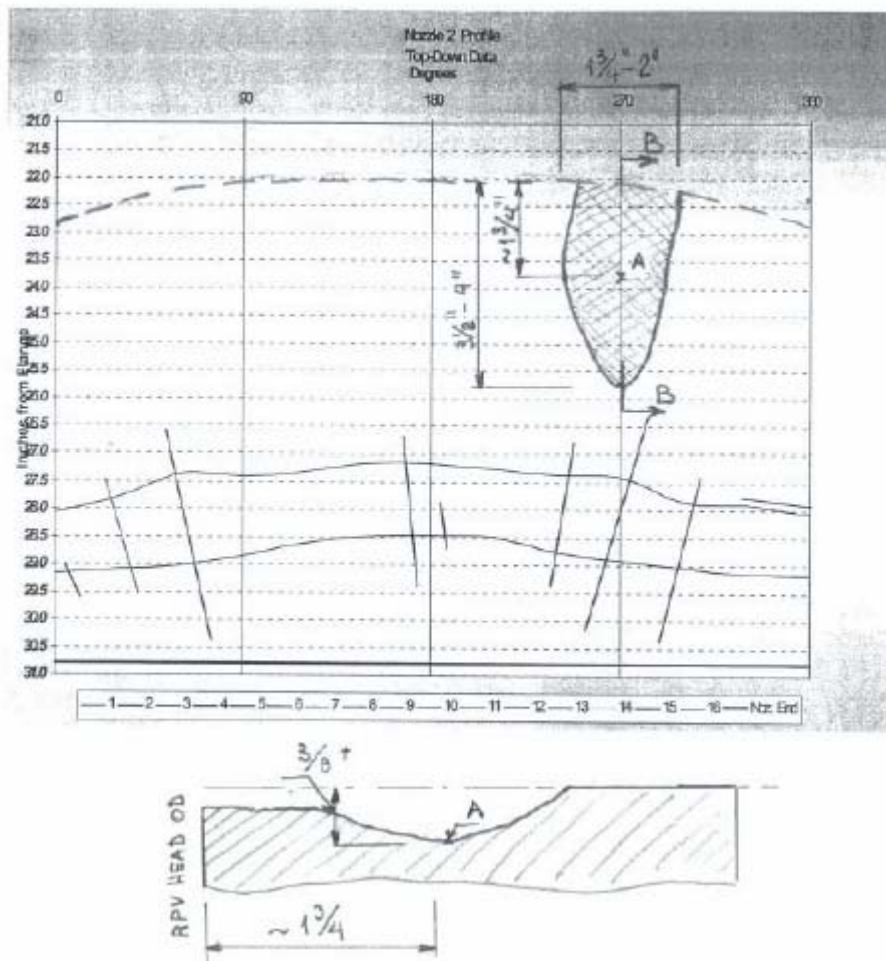
- The wastage cavity was located above three of the through wall axial cracks in Nozzle 2, in the upper half of the nozzle bore, centered on the 270° location.
- The wastage area was located 180° away from the two longest axial cracks in Nozzle 2, which were either side of the 90° location.

- Enlargement of the annulus clearance at the upper surface of the RPV head was observed at approximately the 90° location.
- None of the axial cracks extended up into the wastage cavity.
- The wastage area extended approximately 3 ½ to 4 inches down from the upper surface of the RPV head and was 50° (1 ¾ inches) in circumferential extent.
- The maximum penetration of the cavity into the RPV head was approximately 3/8 inch in the radial direction away from the nozzle OD, and this maximum point was approximately 1 ¾ inches below the upper surface of the RPV head. This indicates that whatever processes of mechanical removal, corrosion, or flow-assisted corrosion were active; the cavity was growing at its maximum rate sub-surface.

Figure 10-6 Wastage Cavity at CRDM Nozzle 2

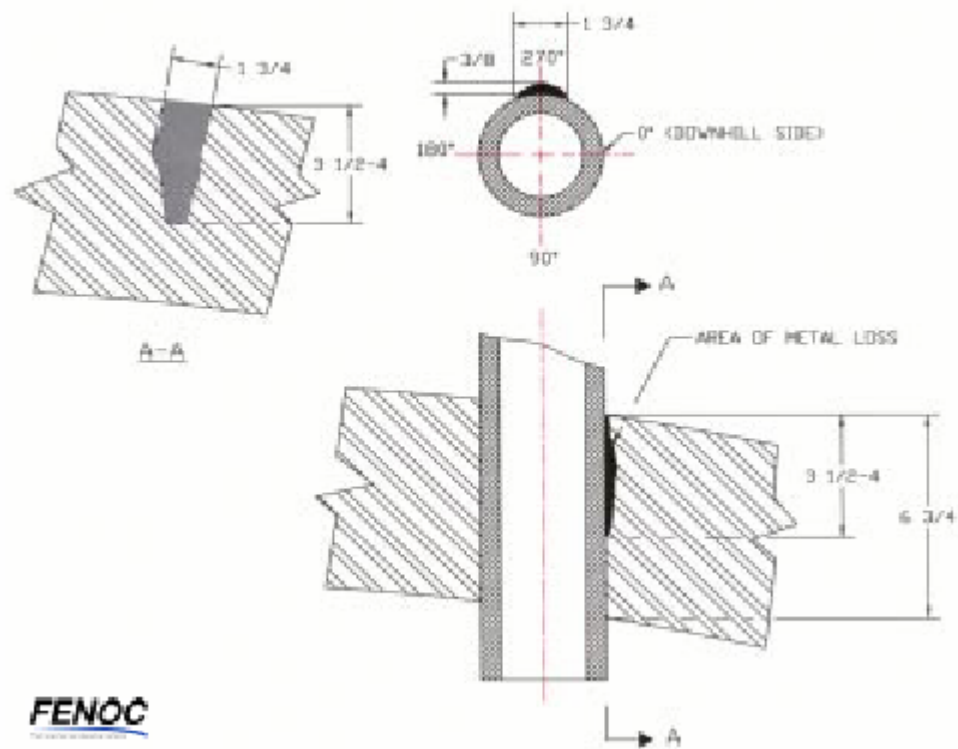
Nozzle 2 Corrosion Profile

Figure 10-7 Wastage Cavity at CRDM Nozzle 2

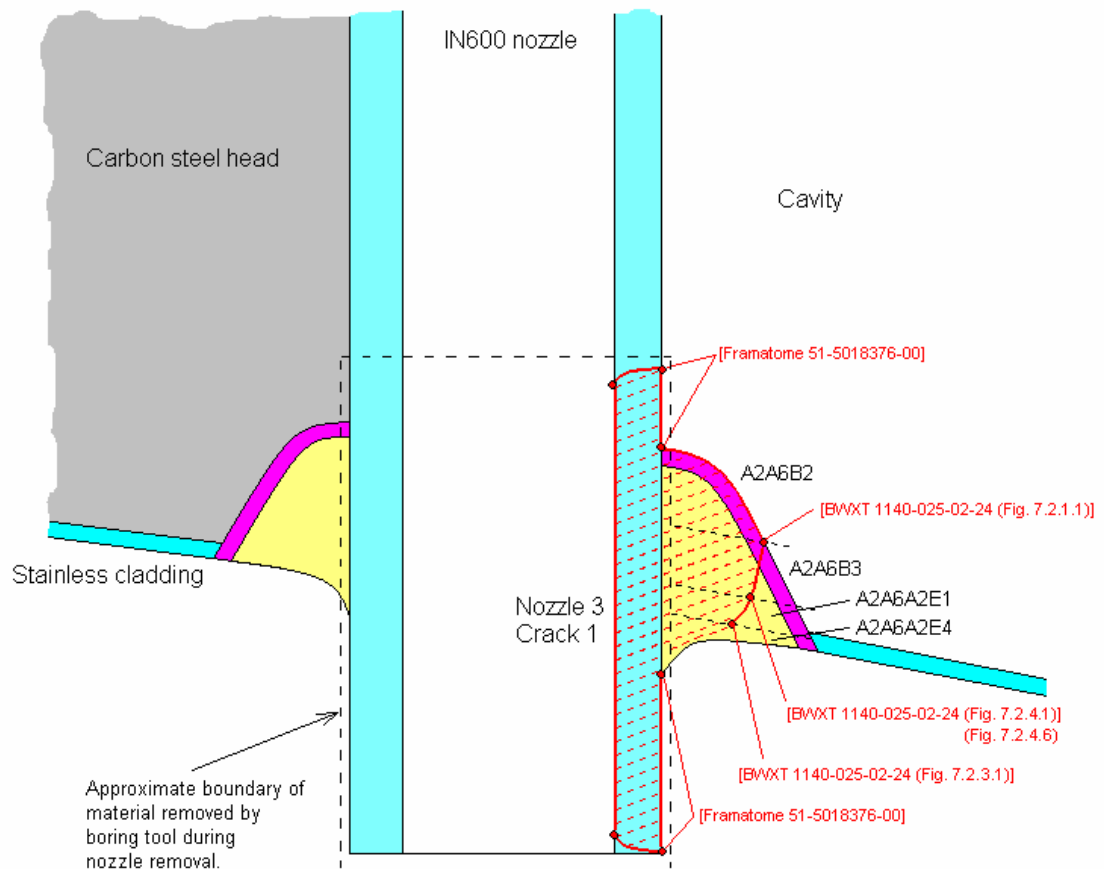
However, careful metallurgical examination of the portion of the J-groove weld that remained after the RPV head section containing the cavity was removed from the RPV head, together with the UT data, allowed us to build up a composite picture of the large nozzle and weld crack at CRDM Nozzle 3 that is shown in Figure 10.8 (See Section 8.4.2).

- A large axial through-wall crack (Crack 1) at the 3° location at the top of the J-groove weld extended from almost the bottom of Nozzle 3 to 1.23 inches above the weld on the OD.
- This axial nozzle crack appears to have extended into and almost completely across the J-groove weld at Nozzle 3.
- The metallurgical examination of this weld crack showed that it was quite wide and extended approximately 0.75 inches across the weld in the radial direction at the 10° location (Figures 10.9 through 10.14).
- The weld crack was in line with the upward bulge and crack in the stainless steel cladding at the bottom of the wastage cavity. The bulge in the cladding may have contributed to opening of the weld crack.

The fact that the weld crack and to a lesser extent the nozzle crack at Nozzle 3 are in line with the centerline and “nose” of the wastage cavity at approximately the 10° location indicate that they are manifestations of the same crack. This crack, more likely than not, initiated on the nozzle OD below the weld, and then propagated axially up through the nozzle wall around the weld, radially towards the ID eventually reaching through-wall, and radially out through the weld. The possibility of multiple initiation sites on both the OD and ID of the nozzle cannot be ruled out, and this would have shortened the overall time for the crack to reach the top of the weld and begin leaking (see Section 8.1.1).

Figure 10.8 Schematic of final size and shape of Crack 1 in Davis-Besse CRDM Nozzle 3 (from Section 8, Figure 8-10)

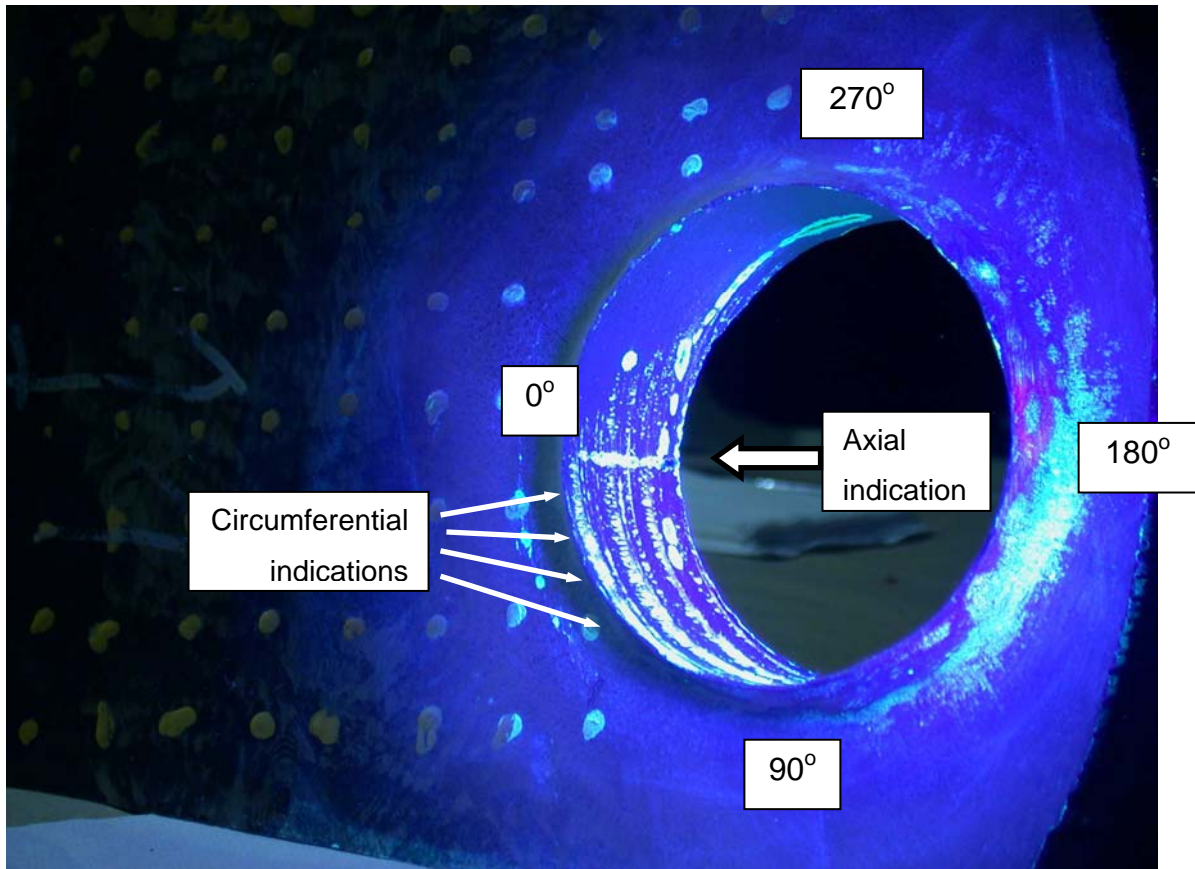
Figure 10.9 PT results for nozzle 3 J-groove weld bore and cladding underside. The J-groove weld contained an axial indication near 10° on the bore ID and circumferential indications on the RCS side from ~20° to ~45°.

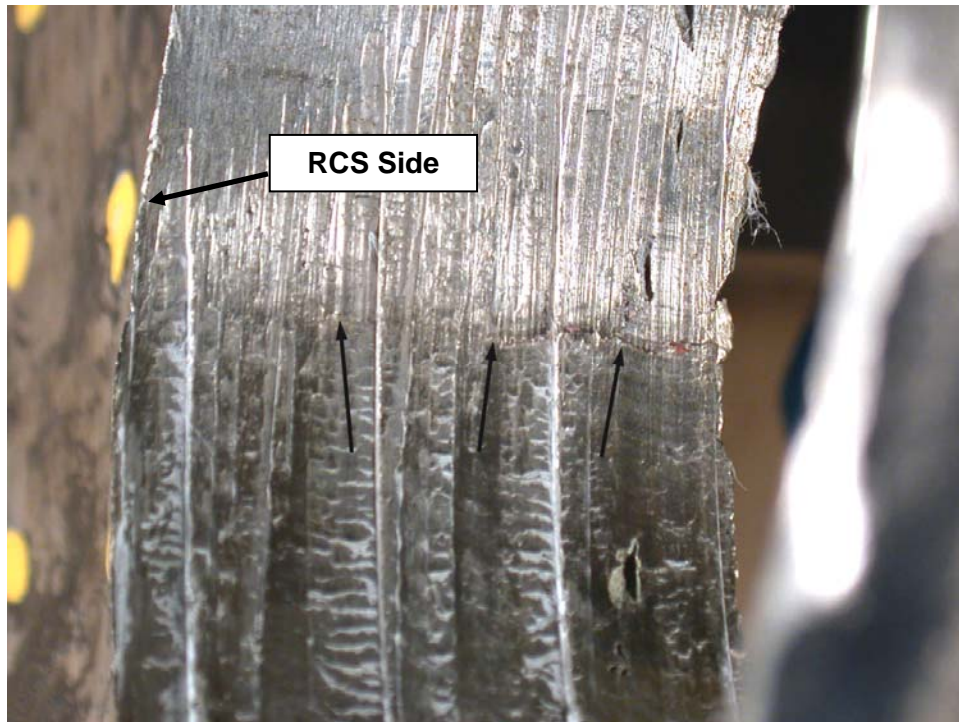
Looking at J-groove weld bore near 10°. ~1.2X

Figure 10.10 Photograph showing the remaining portion of the axial crack near 10° in the CRDM Nozzle 3 J-groove weld. This is the portion remaining after the machining was completed for nozzle repair.

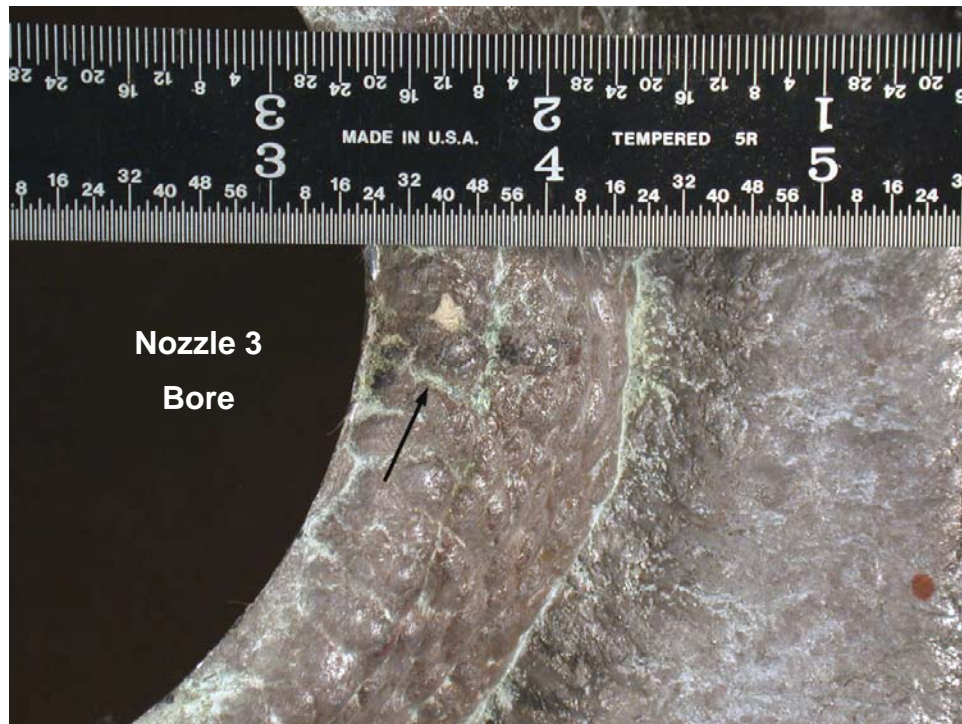
Top view of J-groove weld crack near 10°. ~1.4X

Figure 10.11 Photograph showing axial crack in CRDM nozzle 3 J-groove weld near 10°.

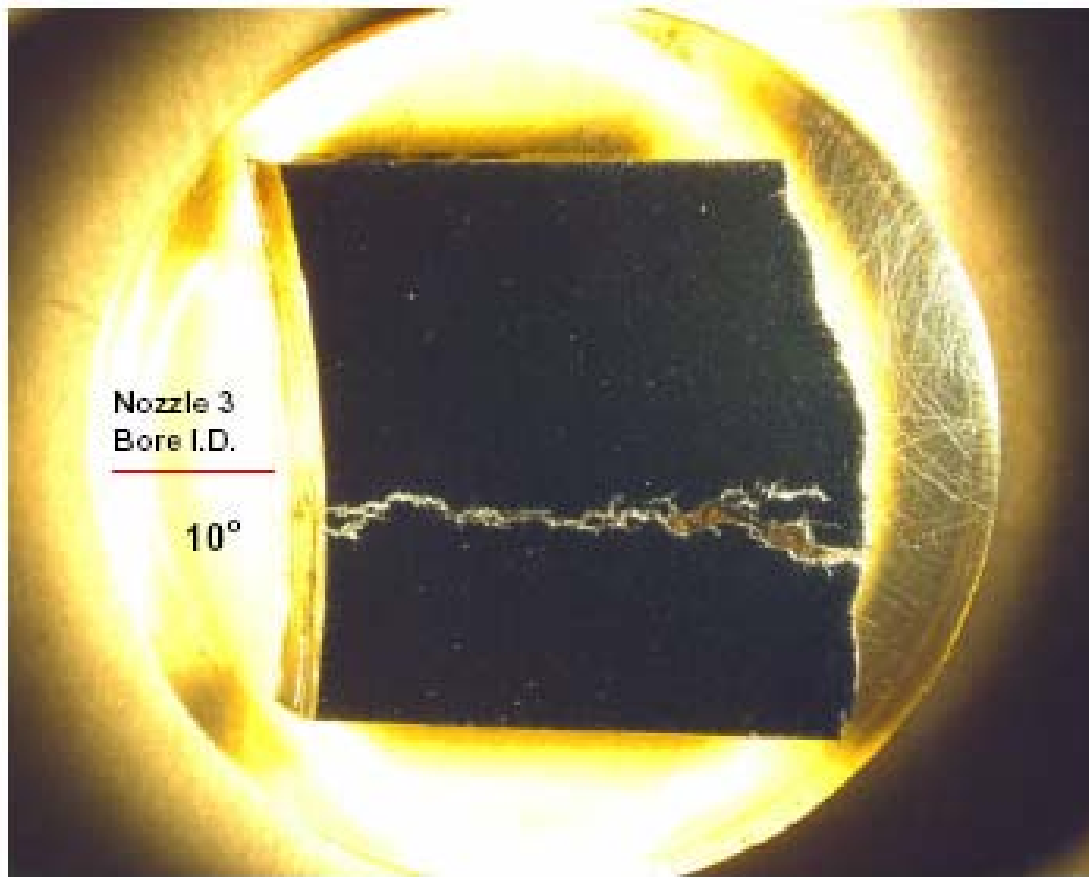
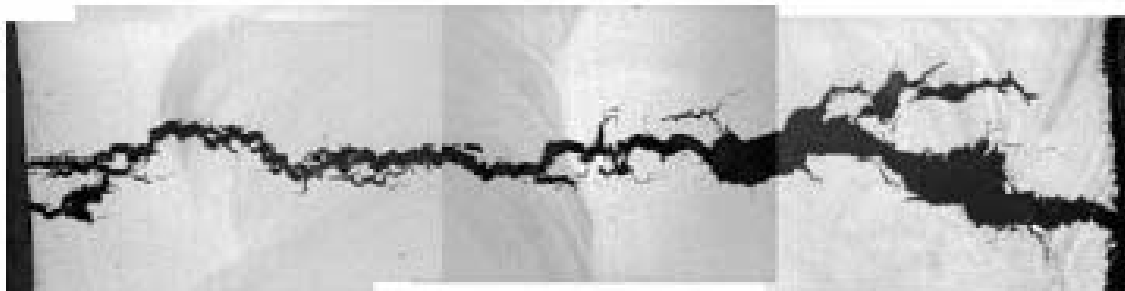
Figure 10.14 Macro photograph of metallographic mount sample A2A6B2 (see Figures 5.4 and 5.5 for the sample orientation). The axial cracking at $\sim 10^\circ$ is through the J-groove weld, in contrast to the cracking near 180° , which was partially through the weld. A slightly higher magnification micrograph is also provided
